Subject: Transmittal of Quarterly Site Progress Report, Third Quarter 2014

2000 Race Street Site, Baltimore, Maryland

Third Quarter 2014 Race Street Quarterly Site Progress Report, 2000 Race Street, Baltimore, Maryland

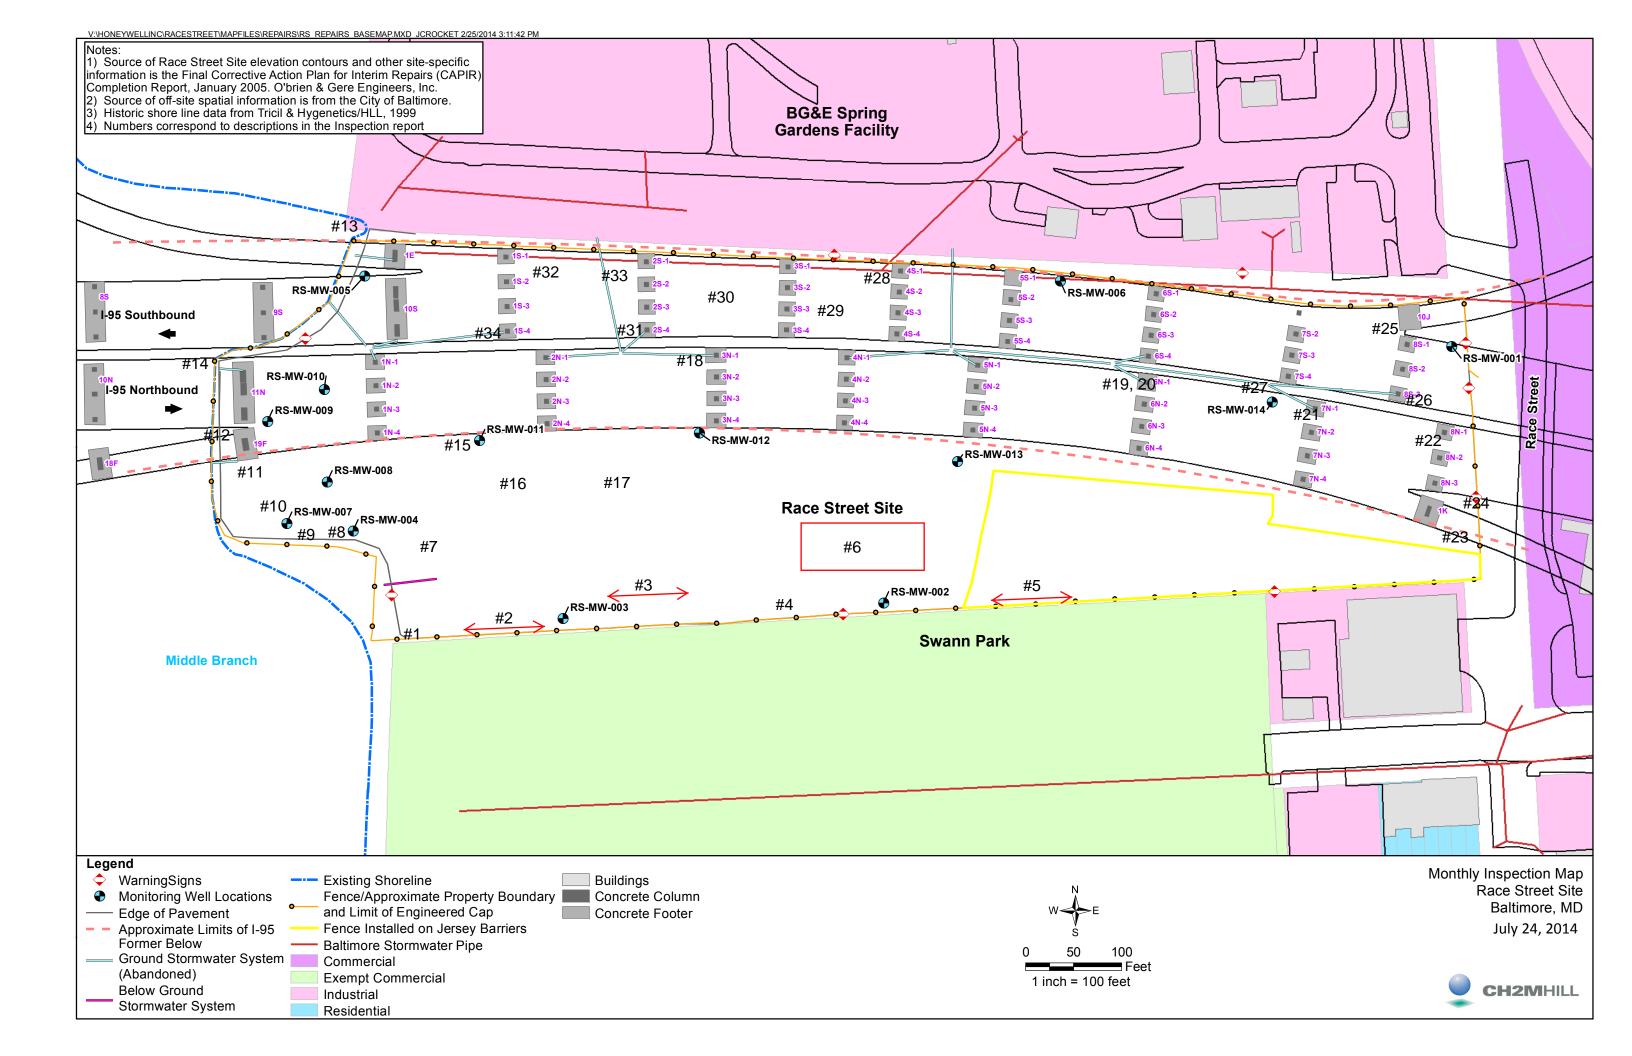
Inspector:	Bill Morris	Date of Inspection:	24-Jul-14	
Title:	Environmental Engineer	Date of Last Inspection:		19-Jun-14
Organization:	CH2M HILL	Weather:		Overcast, warm
O'te been estern	Paradia			
Site Inspection		Astissas Talesas	Data Camalatad	O a marga and a /A delition and Observations
Task	Observations	Actions Taken	Date Completed	Comments/Additional Observations

1. General	22. Troop and debrie	Mono	INIA	City porformed city wide cleanup during June 2014
Inspect site for presence of surface debris. Identify type, approximate volume of debris, and location via description or on Site Plan (attach to Monthly Site Inspection Checklist).		None	NA	City performed site-wide cleanup during June 2014 and will schedule future periodic trash cleanups.
Inspect site for presence of vegetation. Identify estimated amount and location of vegetation via description or on Site Plan (attach to Monthly Site Inspection Checklist)	None	None	NA	NA

2. Interstate 95 Footings and Joints				
Inspect around pier footings for settlement. Identify settlement off-set from grade and location via description or on Site Plan (attach to Monthly Site Inspection Checklist)	11: Vegetation around footings	Area identified for site maintenance.		City is planning to perform site maintenance including vegetation control during Q4 2014.
Inspect around pier footings for joint failure. Identify location via description or on Site Plan (attach to Monthly Site Inspection Checklist)	None	None	NA	NA

3. Engineered Cap				
Inspect cap for alligator cracking. Identify estimated area of cracking and location via description or on Site Plan (attach to Monthly Site Inspection Checklist)	6: Alligator cracking with localized ponding 16, 17: Alligator cracking	Area identified for site maintenance.	TBD	City is planning to perform surface cover maintenance including crack sealing during Q4 2014.
Inspect cap for holes. Identify number of holes, width and depth, and location via description of on Site Plan (attach to Monthly Site Inspection Checklist)	8: hole in asphalt with vegetation.	Area identified for site maintenance.	TBD	City is planning to perform surface cover maintenance and vegetation control during Q4 2014.
Inspect cap for cracks less than 0.5 inches wide. Note number of cracks. Identify location of cracks via description or on Site Plan (attach to Monthly Site Inspection Checklist).	3: Surface crack with vegetation	Area identified for site maintenance.	TBD	City is planning to perform surface cover maintenance and vegetation control during Q4 2014.

Inspect cap for cracks greater than 0.5 inches wide. Note number of cracks. Identify location of cracks via description or on Site Plan (attach to Monthly Site Inspection Checklist).	7: Surface crack with vegetation	Area identified for site maintenance.	TBD	City is planning to perform surface cover maintenance and vegetation control during Q4 2014.
Inspect cap for any signs of ponding of water	9, 30: Localized area with ponding water	Area identified for site maintenance.	TBD	City is planning to perform surface cover maintenance during Q4 2014.
Inspect shorefront embankment for evidence of erosion or releases	None	None	NA	NA
Identify any other observations related to the condition of the cap and potential for cap damage	24: Erosion at top of slope 28: Sinkhole repair	Area identified for site maintenance.		City is planning to perform surface cover maintenance during Q4 2014.

0:1	<u> </u>	Tilispection Checklist		
Site Inspection			15.0	
Task	Observations	Actions Taken	Date Completed	Comments/Additional Observations
Inspect fence for holes. Note number of holes. Identify location of holes via description or on Site Plan (attach to Monthly Site Inspection Checklist).	1: Hole in fence	City representative notified.	7/29/2014	City of Baltimore is planning to perform site maintenance including fence repair during Q4 2014.
Inspect fence to determine if there is any erosion compromising the integrity of the fence	None	None	NA	NA
Inspect fence to determine if barbed wire is in good condition	None	None	NA	NA
Inspect gates, chains, and locks for damage	None	None	NA	NA
Inspect fence to determine if any vegetation is damaging or otherwise compromising fence	2, 5, 32: Vegetation along fence	None		City of Baltimore planning to apply herbicide and remove vegetation from cracks in asphalt surface during Q4 2014.

5. Aboveground Stormwater Conveyance System	i		1	
Inspect aboveground stormwater conveyance system including piping, downspouts, and drain in southwest corner of site for proper operation	4: Localized degradation of asphalt curb. 12, 19, 20, 25: Missing water downspout. 14: Dried grout material at downspout outlet. 19, 21, 22, 26, 31, 34: Disconnected storm water conveyance pipe for the I-95 overpass.	MDTA is in the process of conducting bridge maintenance.	TBD	MDTA is performing bridge maintenance during Q3 and Q4 2014.

8. Miscellaneous Items	<u>I</u>	I.	1	<u>I</u>
Any interaction with people on or adjacent to the site? If yes, identify who, title, organization, contact information, and content of interaction	Josh Floyd of ERM was on site for the month	ly inspection.		
Other Comments/Observations?	13: Burrow hole at edge of cap; 10, 15, and 27 - Bent bollards around existing monitoring wells

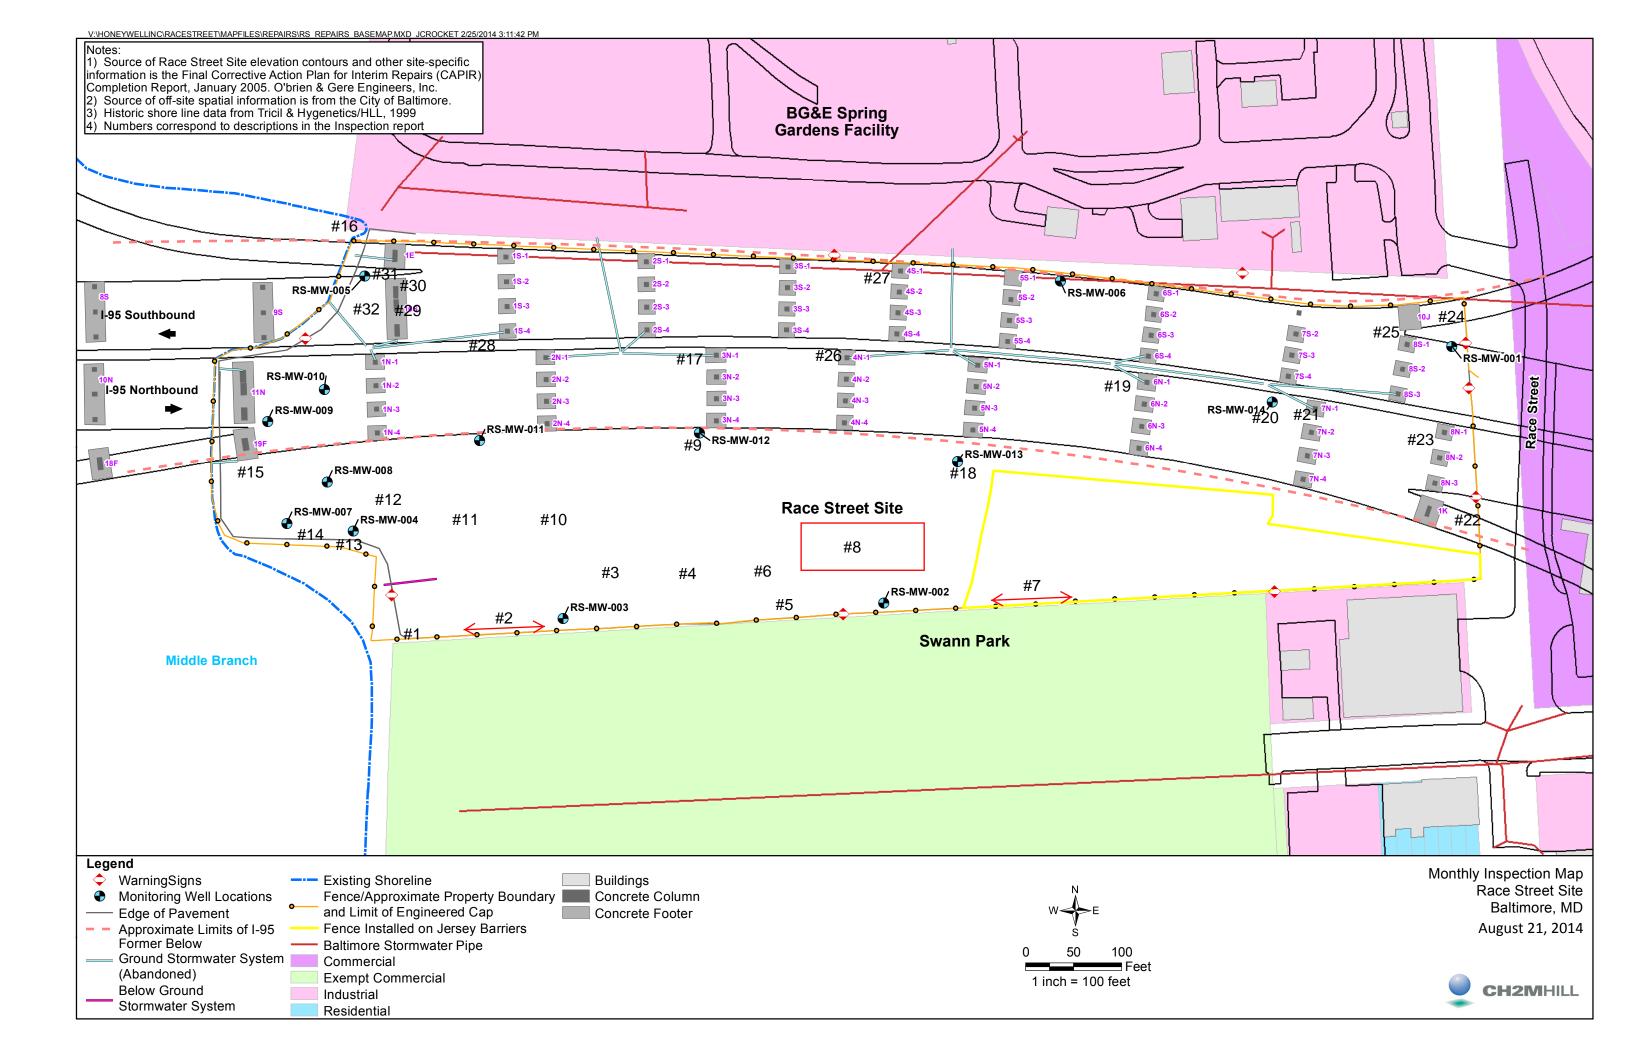
Inspector:	Bill Morris	Date of Inspection:	21-Aug-14	
Title:	Environmental Engineer	Date of Last Inspection:	24-Jul-14	
Organization:	CH2M HILL	Weather:	Overcast, warm	
Site Inspection	Pagulto			
Task	Observations	Actions Taken	Date Completed	Comments/Additional Observations

1. General	Observations	Actions Taken	Date Completed	Comments/Additional Observations
Inspect site for presence of surface debris. Identify	24: Trash and debris	None	NA	City performs periodic trash cleanups.
type, approximate volume of debris, and location via description or on Site Plan (attach to Monthly Site Inspection Checklist).				ony ponomia ponodia nadin diadinapa.
Inspect site for presence of vegetation. Identify	None	None	NA	NA
estimated amount and location of vegetation via description or on Site Plan (attach to Monthly Site Inspection Checklist)

3. Engineered Cap	Taranta and an incident		I	
Inspect cap for alligator cracking. Identify estimated area of cracking and location via description or on Site Plan (attach to Monthly Site Inspection Checklist)	8,10,11, 32: Alligator cracking on the asphalt surface	Areas identified for site maintenance.	TBD	City is planning to perform surface cover maintenance during Q4 2014.
Inspect cap for holes. Identify number of holes, width and depth, and location via description of on Site Plan (attach to Monthly Site Inspection Checklist)	14: two small holes in the asphalt with vegetation 30: Hole in the asphalt near pile cap	Areas identified for site maintenance.		City is planning to perform surface cover maintenance and vegetation control during Q4 2014.
Inspect cap for cracks less than 0.5 inches wide. Note number of cracks. Identify location of cracks via description or on Site Plan (attach to Monthly Site Inspection Checklist).	6, 12: Surface crack with vegetation	Areas identified for site maintenance.		City is planning to perform surface cover maintenance and vegetation control during Q4 2014.

Inspect cap for cracks greater than 0.5 inches wide. Note number of cracks. Identify location of cracks via description or on Site Plan (attach to Monthly Site Inspection Checklist).	3, 4, 15: Surface crack with vegetation	Areas identified for site maintenance.		City is planning to perform surface cover maintenance and vegetation control during Q4 2014.
Inspect cap for any signs of ponding of water	28: Localized ponding water on asphalt surface	Areas identified for site maintenance.		City is planning to perform surface cover maintenance during Q4 2014.
Inspect shorefront embankment for evidence of erosion or releases	None	None	NA	NA
Identify any other observations related to the condition of the cap and potential for cap damage	22: Erosion at top of the slope 27: Sinkhole	Areas identified for site maintenance.		City is planning to perform surface cover maintenance during Q4 2014.

Site Inspection	Results			
Task	Observations	Actions Taken	Date Completed	Comments/Additional Observations
Inspect fence for holes. Note number of holes. Identify location of holes via description or on Site Plan (attach to Monthly Site Inspection Checklist).	1: Hole in the fence.	Assessment conducted by City's contractor.	8/21/2014	City is planning to perform site maintenance during Q4 2014.
Inspect fence to determine if there is any erosion compromising the integrity of the fence	None	None	NA	NA
Inspect fence to determine if barbed wire is in good condition	None	None	NA	NA
Inspect gates, chains, and locks for damage				
Inspect fence to determine if any vegetation is damaging or otherwise compromising fence	2, 7: Vegetation growth along the fence	Assessment conducted by City's contractor.	8/21/2014	City is planning on performing vegetation control as part of site maintenance during Q4 2014.
Inspect fence to determine if there is any burrowing beneath fence	None	None	NA	NA

5. Aboveground Storm water Conveyance System	n	1	· I	
Inspect aboveground storm water conveyance system including piping, downspouts, and drain in southwest corner of site for proper operation	5: Localized degradation of asphalt curb 17, 19, 21, 23, 25: Missing or disconnected storm water downspout 19, 21, 23: Disconnected storm water conveyance pipe on the I-95 overpass	Areas identified for site maintenance.	TBD	City is planning to perform surface cover repairs during Q4 2014. MDTA is performing bridge maintenance during Q3 and Q4 2014.

8. Miscellaneous Items			<u> </u>	
Any interaction with people on or adjacent to the site? If yes, identify who, title, organization, contact information, and content of interaction	Josh Floyd of ERM and Jim Leizear of MDE	were on site during the monthly insp	ection.	
Other Comments/Observations?	9,13,18, 20: Bent bollard around well head 16: Borrow hole near outfall structure 26: Construction material wash water at storm water downspout 29, 31: Grout wash water observed across asphalt paved ground surface from bridge maintenance activities. MDE personnel were onsite during site visit and MdTA immediately notified whereby they dispatched contractors to contain and cleanup wash water and grout residue.

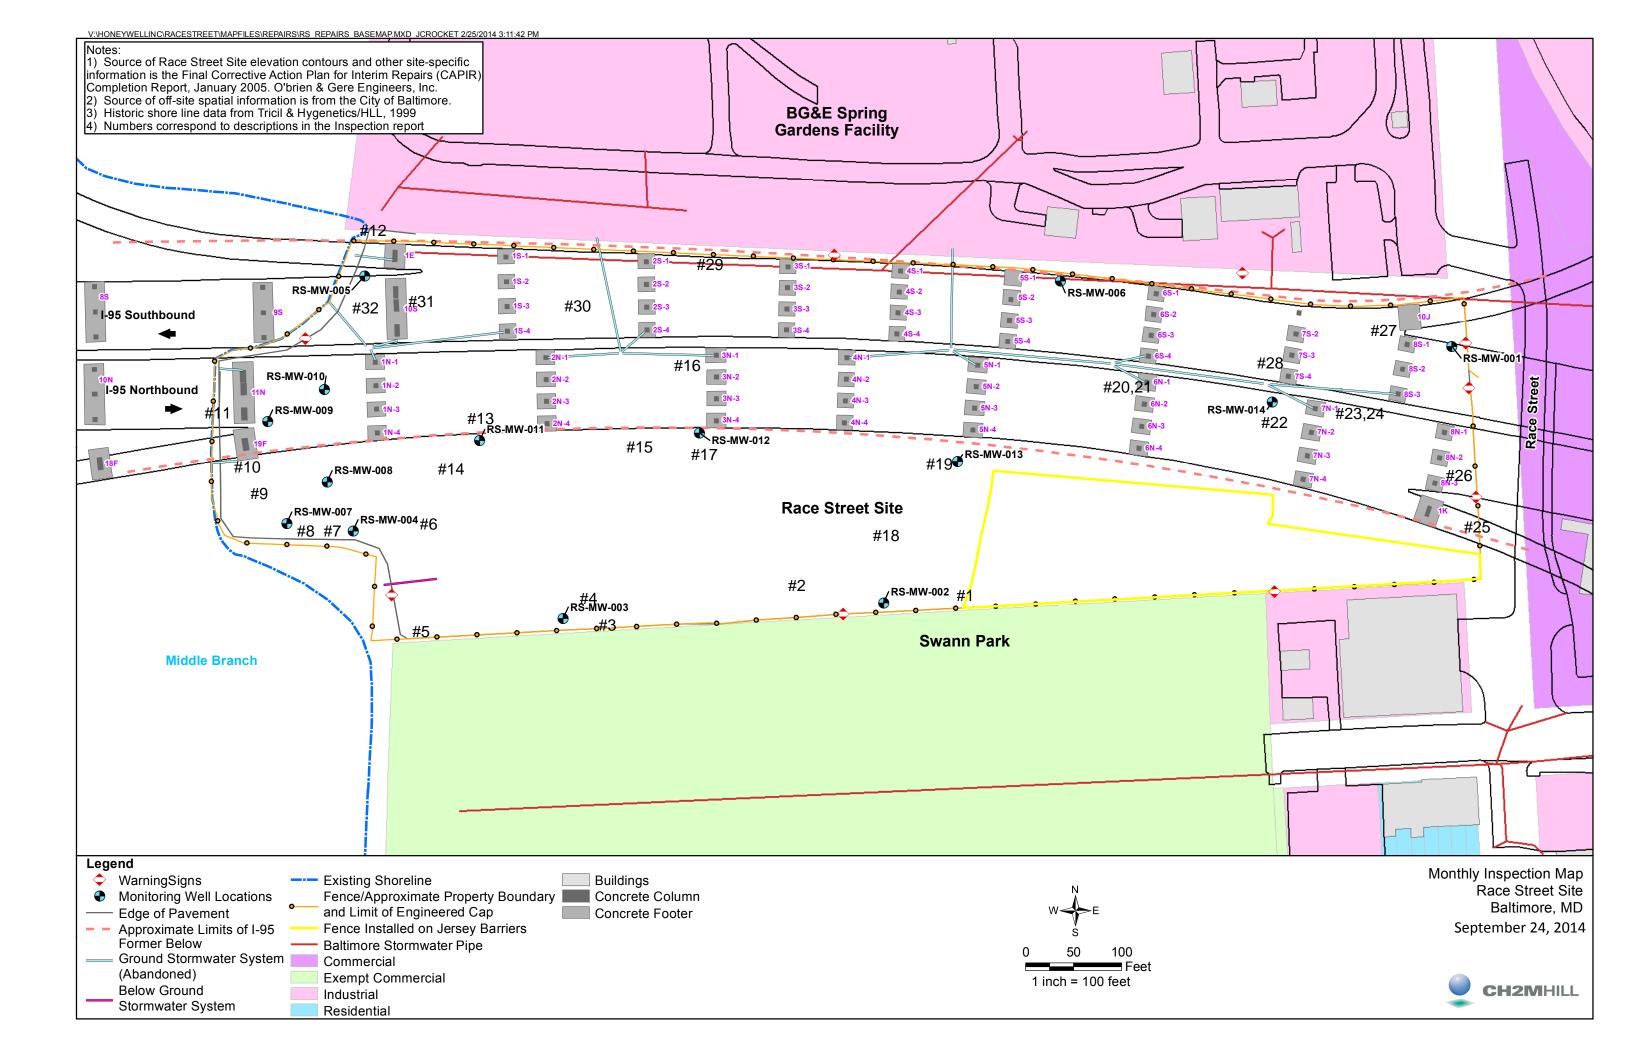
Inspector:	Bill Morris	Date of Inspection:	24-Sep-14	
Title:	Environmental Engineer	Date of Last Inspection:	21-Aug-14	
Organization:	CH2M HILL	Weather:		Cool, Cloudy
Site Inspection				
Task	Observations	Actions Taken	Date Completed	Comments/Additional Observations

3. Engineered Cap				
Inspect cap for alligator cracking. Identify estimated	14, 15, 18: Alligator cracking	Areas identified for site	TBD	City is planning to perform surface cover
area of cracking and location via description or on		maintenance.		maintenance during Q4 2014.
Site Plan (attach to Monthly Site Inspection				
Checklist)				
Inspect cap for holes. Identify number of holes, width	7: two holes in the asphalt with vegetation	Areas identified for site	TBD	City is planning to perform surface cover
and depth, and location via description of on Site	31: Hole in the asphalt near pile cap	maintenance.		maintenance including vegetation control during Q4
Plan (attach to Monthly Site Inspection Checklist)	· · ·			2014.
Inspect cap for cracks less than 0.5 inches wide.	2, 4, 6, 9, 29: Surface cracks with vegetation	Areas identified for site	TBD	City is planning to perform surface cover
Note number of cracks. Identify location of cracks via		maintenance.		maintenance including vegetation control during Q4

description or on Site Plan (attach to Monthly Site				2014.
Inspection Checklist).				
Inspect cap for cracks greater than 0.5 inches wide.	10: Vegetation growth at base of pile cap	Areas identified for site	TBD	City is planning to perform surface cover
Note number of cracks. Identify location of cracks via		maintenance.		maintenance including vegetation control during Q4
description or on Site Plan (attach to Monthly Site				2014.
Inspection Checklist).				
Inspect cap for any signs of ponding of water	30: localized ponding of water following	Areas identified for site	TBD	City is planning to perform surface cover
	precipitation events	maintenance.		maintenance during Q4 2014.
Inspect shorefront embankment for evidence of	None	None	NA	NA
erosion or releases				
Identify any other observations related to the	None	None	NA	NA
condition of the cap and potential for cap damage	110110	110.10		
on and out and potential for cap darriage

Site Inspection	Results			
Task	Observations	Actions Taken	Date Completed	Comments/Additional Observations
Inspect fence for holes. Note number of holes. Identify location of holes via description or on Site Plan (attach to Monthly Site Inspection Checklist).	5: Hole in the fence	Areas identified for site maintenance.	TBD	City is planning to repair the fence as part of scheduled site maintenance during Q4 2014.
Inspect fence to determine if there is any erosion compromising the integrity of the fence	25: Localized erosion at cap edge	Areas identified for site maintenance.	TBD	City is planning to perform surface cover maintenance during Q4 2014.
Inspect fence to determine if barbed wire is in good condition	None	None	NA	NA
Inspect gates, chains, and locks for damage				
Inspect fence to determine if any vegetation is damaging or otherwise compromising fence	1: Vegetation growth along the fence	Areas identified for site maintenance.		City is planning to perform vegetation control as part of site maintenance during Q4 2014.

5. Aboveground Storm water Conveyance System	<u> </u>		•	
Inspect aboveground storm water conveyance system including piping, downspouts, and drain in southwest corner of site for proper operation	11, 22, 28: Construction material wash water from a storm water downspout 16, 21, 24, 27: Missing or disconnected storm water downspout 20, 23, 26: Disconnected storm water conveyance pipe for the I-95 overpass	MDTA maintenance activities resumed.	9/11/2014	MDTA is performing bridge maintenance during Q3 and Q4 2014. MDTA has directed its contractor to complete a cleanup of residual grout material on the asphalt paved surface.

8. Miscellaneous Items		•	,	
Any interaction with people on or adjacent to the site? If yes, identify who, title, organization, contact information, and content of interaction	Josh Floyd of ERM and Jim Leizear of MDE were on site for the monthly inspection. MDTA's contractor was on site conducting maintenance activities on the I-95 overpass.			
Other Comments/Observations?	8, 13, 17 19, 22: Bent bollard around well head 12: hole in cap near outfall structure 32: Grout and construction material wash water from bridge maintenance activities observed on asphalt surface (MdTA's contractor is in the process of cleaning up residual materials on asphalt surface).
