Re: Transmittal of Quarterly Site Progress Report, Fourth Quarter 2017 2000 Race Street Site, Baltimore, Maryland

Fourth Quarter 2017 Race Street Quarterly Site Progress Report, 2000 Race Street, Baltimore, Maryland

Appendix A Site Inspection Reports

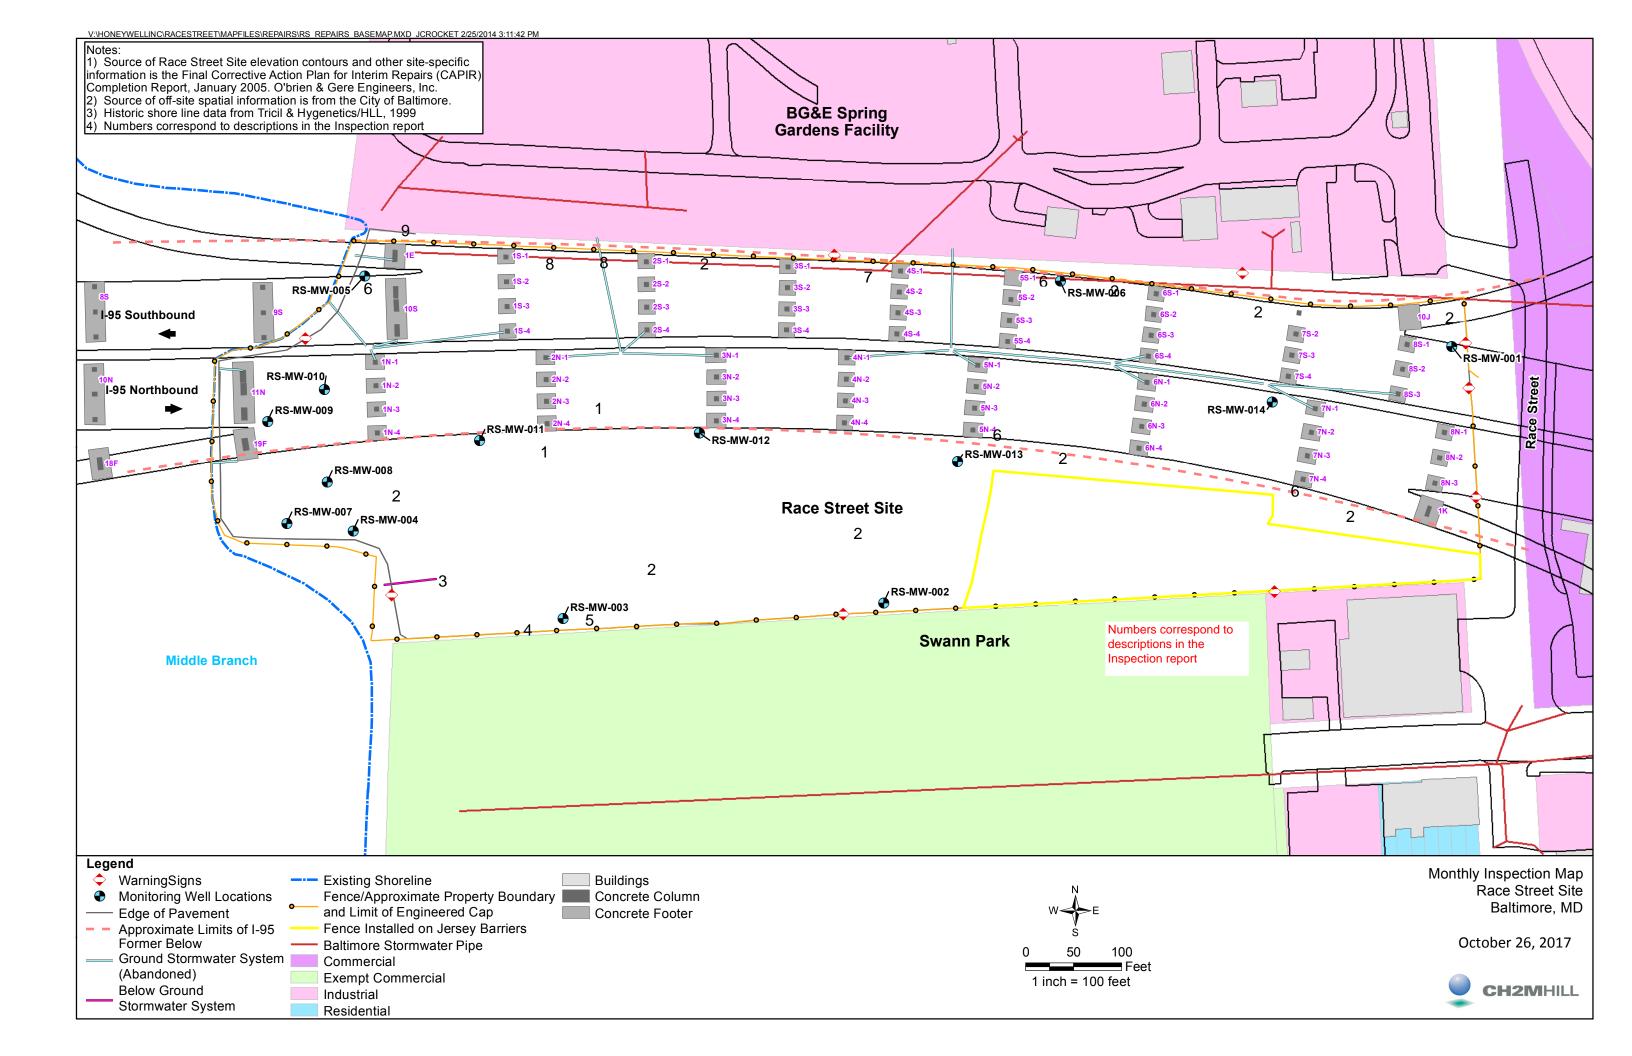
3. Engineered Cap				
Inspect cap for alligator cracking. Identify estimated area of cracking and location via description or on Site Plan (attach to Monthly Site Inspection Checklist)	7: Alligator cracking in asphalt near fence line.	None	NA	Surface cover repairs to be addressed in 2018 as part of scheduled site maintenance and cap repairs.
Inspect cap for holes. Identify number of holes,	9: Hole in asphalt outside of fence 4: Damage to asphalt covering slope.	None	NA	Surface cover repairs to be addressed in 2018 as part of scheduled site maintenance and cap repairs.

3: Crack with vegetation between inlet grate and asphalt. 2: Crack in asphalt with vegetation growth 6: Crack between pier footing and asphalt.	None	NA	Surface cover repairs to be addressed in 2018 as part of scheduled site maintenance and cap repairs.
Inspect cap for cracks greater than 0.5 inches wide. Note number of cracks. Identify location of cracks via description or on Site Plan (attach to Monthly Site Inspection Checklist).	None	None	NA	NA
Inspect cap for any signs of ponding of water	1: Ponding water on asphalt	None	NA	Surface cover repairs to be addressed in 2018 as part of scheduled site maintenance and cap repairs.
Inspect shorefront embankment for evidence of erosion or releases	None	None	NA	NA
Identify any other observations related to the condition of the cap and potential for cap damage	None	None	NA	NA

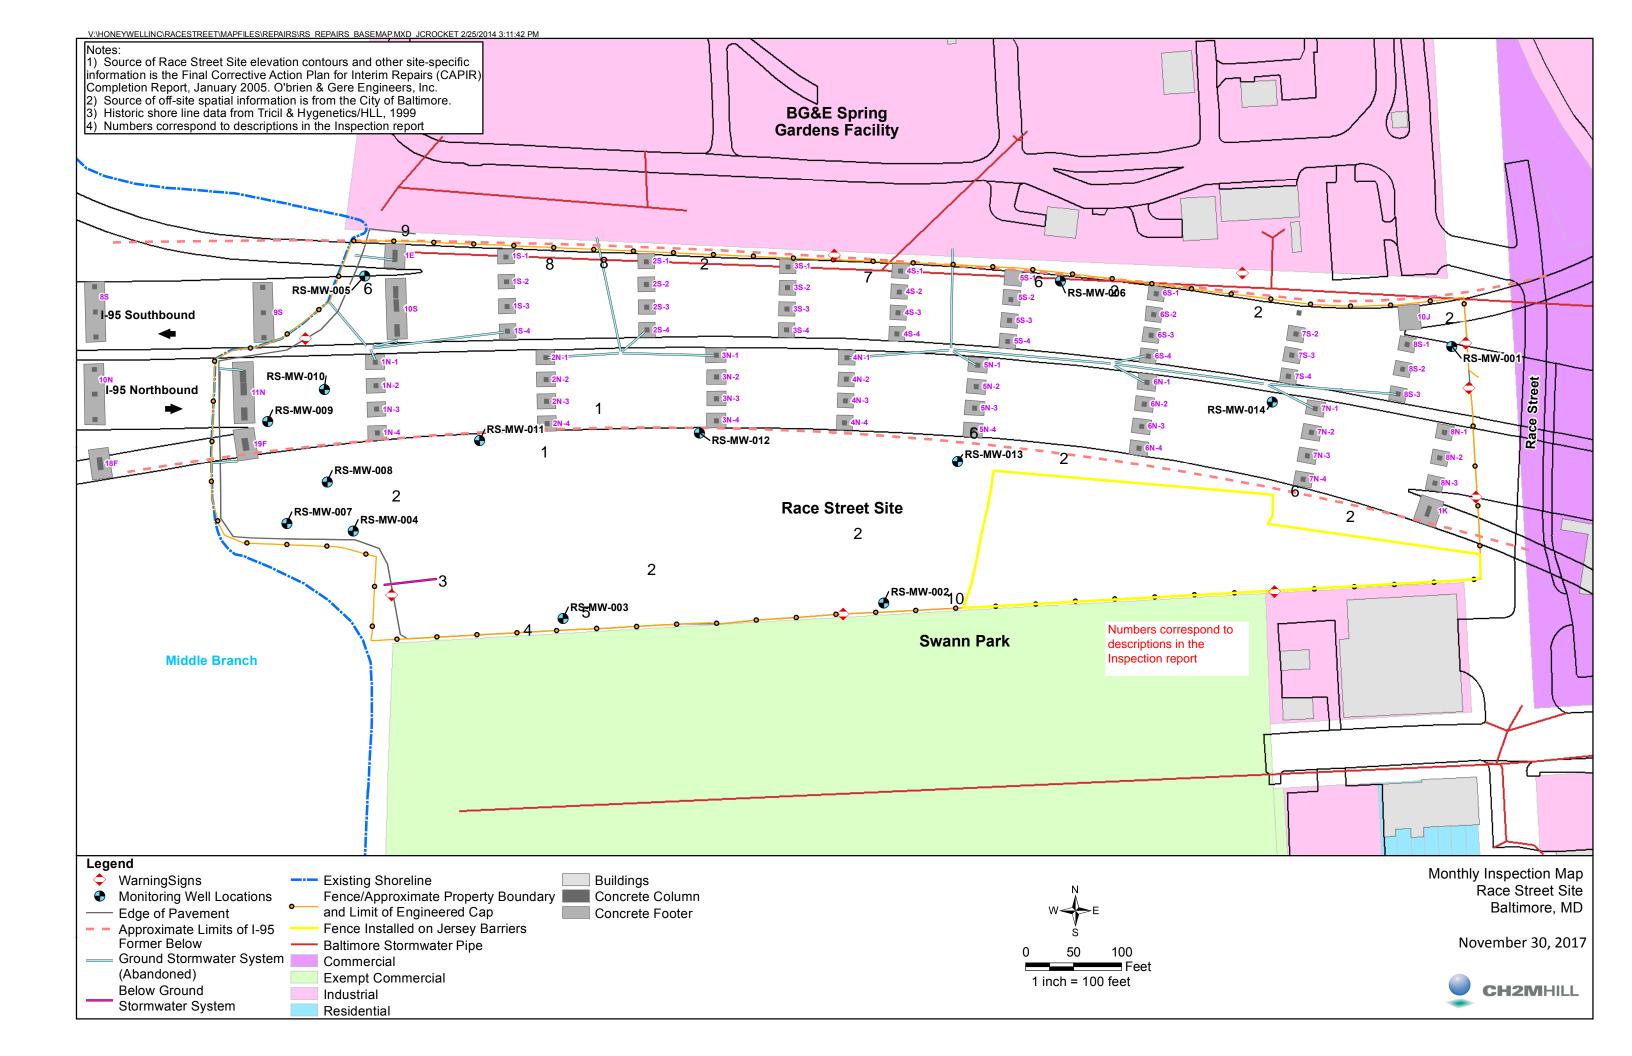
3. Engineered Cap				
Inspect cap for alligator cracking. Identify estimated area of cracking and location via description or on Site Plan (attach to Monthly Site Inspection Checklist)	7: Alligator cracking in asphalt near fence line.	None	NA	Surface cover repairs to be addressed in 2018 as part of scheduled site maintenance and cap repairs.
Inspect cap for holes. Identify number of holes, width and depth, and location via description of on Site Plan (attach to Monthly Site Inspection Checklist)	9: Hole in asphalt outside of fence 4: Damage to asphalt covering slope.	None	NA	Surface cover repairs to be addressed in 2018 as part of scheduled site maintenance and cap repairs.

3: Crack with vegetation between inlet grate and asphalt. 2: Crack in asphalt with vegetation growth 6: Crack between pier footing and asphalt.	None	NA	Surface cover repairs to be addressed in 2018 as part of scheduled site maintenance and cap repairs.
Inspect cap for cracks greater than 0.5 inches wide. Note number of cracks. Identify location of cracks via description or on Site Plan (attach to Monthly Site Inspection Checklist).	None	None	NA	NA
Inspect cap for any signs of ponding of water	1: Ponding water on asphalt	None	NA	Surface cover repairs to be addressed in 2018 as part of scheduled site maintenance and cap repairs.
Inspect shorefront embankment for evidence of erosion or releases	None	None	NA	NA
Identify any other observations related to the condition of the cap and potential for cap damage	None	None	NA	NA

Site Inspection	Results			
Task	Observations	Actions Taken	Date Completed	Comments/Additional Observations
4. Fence	<u> </u>	I		<u> </u>
Inspect fence for holes. Note number of holes. Identify location of holes via description or on Site Plan (attach to Monthly Site Inspection Checklist).	None	None	NA	NA
Inspect fence to determine if there is any erosion compromising the integrity of the fence	None	None	NA	NA
Inspect fence to determine if barbed wire is in good condition	None	None	NA	NA
Inspect gates, chains, and locks for damage	None	None	NA	NA
Inspect gates, criains, and locks for damage Inspect fence to determine if any vegetation is damaging or otherwise compromising fence	None	None	NA	NA
Inspect fence to determine if there is any burrowing beneath fence	None	None	NA	NA
Identify any other observations related to the condition of the fence and potential for fence damage (e.g., points of weakness, corrosion)	10: Damage to the fence.	None	NA	Fence repairs to be addressed in 2018 as part of scheduled site maintenance and cap repairs.

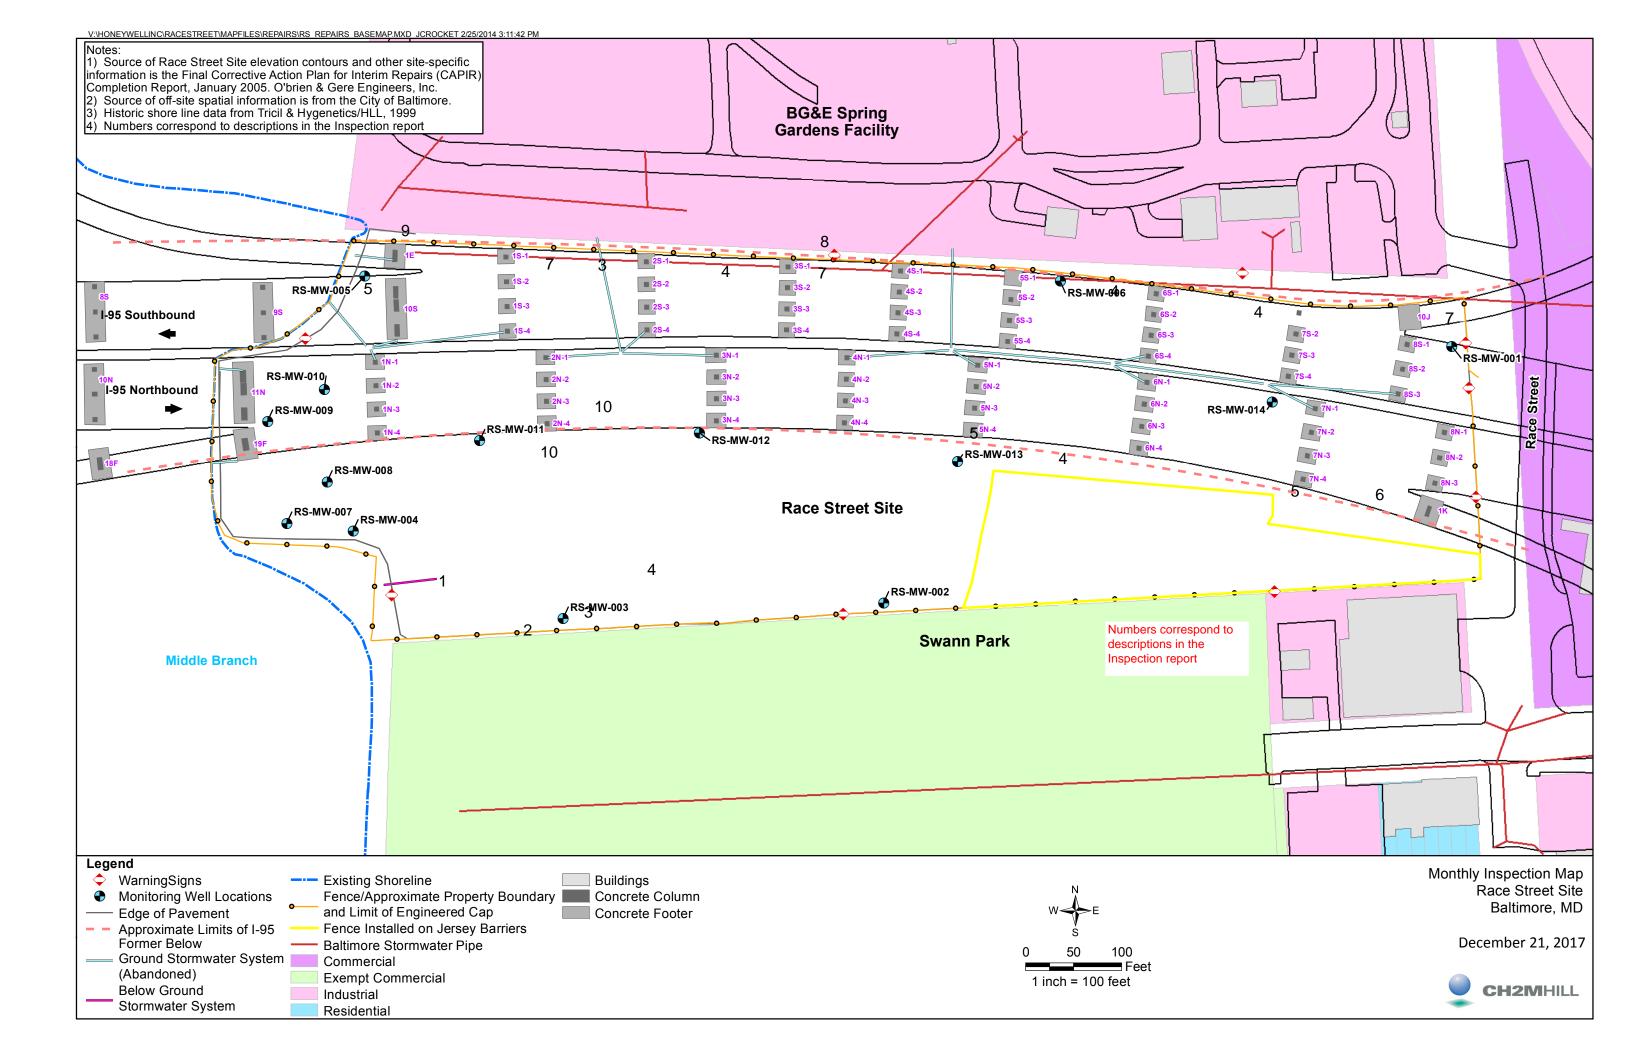
1. General				
Inspect site for presence of surface debris. Identify type, approximate volume of debris, and location via description or on Site Plan (attach to Monthly Site Inspection Checklist).	3: Sediment and debris accumulation.	None	NA	Sediment, debris, and vegetation to be removed in 2018 as part of scheduled site maintenance and cap repairs
Inspect site for presence of vegetation. Identify estimated amount and location of vegetation via description or on Site Plan (attach to Monthly Site Inspection Checklist)	None	None	NA	NA

3. Engineered Cap				
Inspect cap for alligator cracking. Identify estimated area of cracking and location via description or on Site Plan (attach to Monthly Site Inspection Checklist)	7: Alligator cracking in asphalt near fence line.	None	NA	Surface cover repairs to be addressed in 2018 as part of scheduled site maintenance and cap repairs.

9: Hole in asphalt outside of fence 2: Damage to asphalt covering slope. 8: Erosion in grass covered slope.	None	NA	Surface cover repairs to be addressed in 2018 as part of scheduled site maintenance and cap repairs.
Site Inspection Checklist).	Crack with vegetation between inlet grate and asphalt. Crack in asphalt with vegetation growth 5: Crack between pier footing and asphalt.	None	NA	Surface cover repairs to be addressed in 2018 as part of scheduled site maintenance and cap repairs.
Inspect cap for cracks greater than 0.5 inches wide. Note number of cracks. Identify location of cracks via description or on Site Plan (attach to Monthly Site Inspection Checklist).	None	None	NA	NA
Inspect cap for any signs of ponding of water	10: Ponding water on asphalt	None	NA	Surface cover repairs to be addressed in 2018 as part of scheduled site maintenance and cap repairs.
Inspect shorefront embankment for evidence of erosion or releases	None	None	NA	NA

Identify any other observations related to the condition of the cap and potential for cap damage	6: localized damaged asphalt surface	None	NA	Asphalt to be swept and inspected in 2018 after completion of PRB construction.
