Re: Transmittal of Quarterly Site Progress Report, Second Quarter 2018, 2000 Race Street Site, Baltimore, Maryland

Second Quarter 2018 Race Street Quarterly Site Progress Report, 2000 Race Street, Baltimore, Maryland

Appendix A Site Inspection Reports

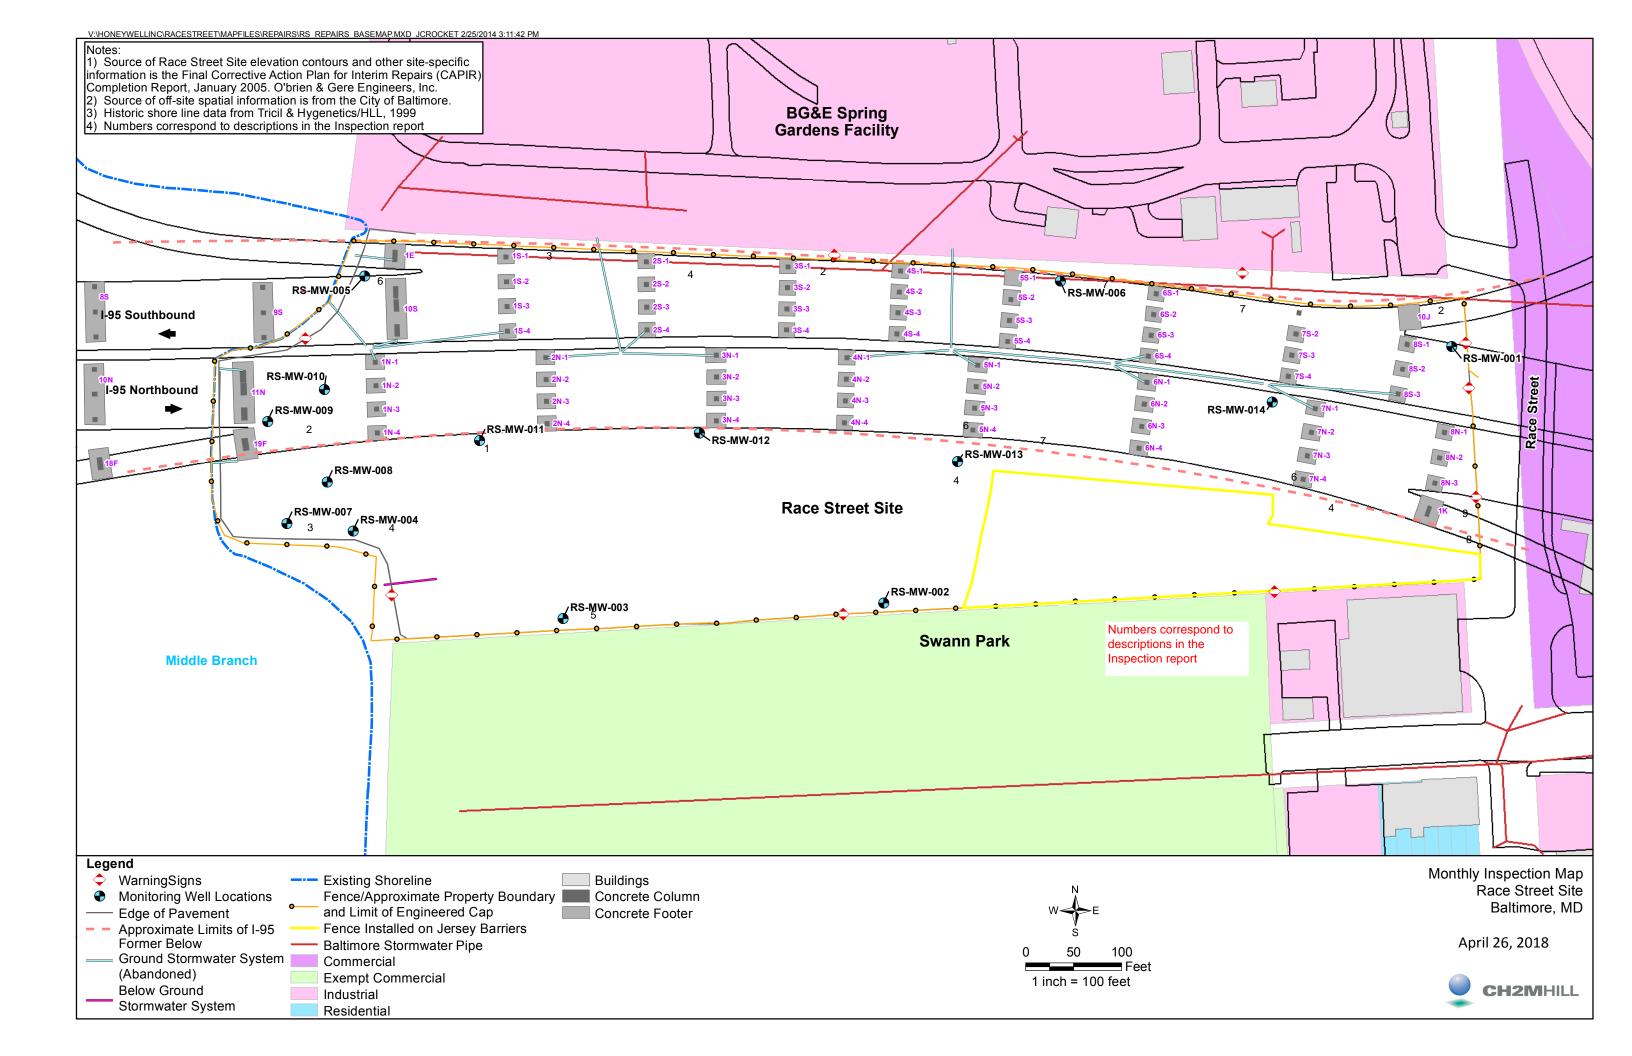
1. General			,	
description or on Site Plan (attach to Monthly Site Inspection Checklist).	Sediment and debris accumulation. Trash accumulation	None	NA	Sediment, debris, and vegetation to be removed in Q2 2018 as part of scheduled site maintenance and cap repairs.
Inspect site for presence of vegetation. Identify estimated amount and location of vegetation via description or on Site Plan (attach to Monthly Site Inspection Checklist)	None	None	NA	NA

3. Engineered Cap				
Inspect cap for alligator cracking. Identify estimated area of cracking and location via description or on Site Plan (attach to Monthly Site Inspection Checklist)	2: Locations having alligator cracking	None	NA	Surface cover repairs to be addressed in Q2 2018 as part of scheduled site maintenance and cap repairs.
Inspect cap for holes. Identify number of holes, width and depth, and location via description of on Site Plan (attach to Monthly Site Inspection Checklist)	None	None	NA	NA
Inspect cap for cracks less than 0.5 inches wide. Note number of cracks. Identify location of cracks via description or on Site Plan (attach to Monthly Site Inspection Checklist).	4: Crack in asphalt with vegetation growth. 6: Cracks between pier footing and asphalt.	None	NA	Surface cover repairs to be addressed in Q2 2018 as part of scheduled site maintenance and cap repairs.
Inspect cap for cracks greater than 0.5 inches wide. Note number of cracks. Identify location of cracks via description or on Site Plan (attach to Monthly Site Inspection Checklist).	5: Asphalt crack along side slope 7: Cracks in asphalt with vegetation growth	None	NA	Surface cover repairs to be addressed in Q2 2018 as part of scheduled site maintenance and cap repairs.

8. Miscellaneous Items	1			
Any interaction with people on or adjacent to the site? If yes, identify who, title, organization, contact information, and content of interaction				
Other Comments/Observations?	1: Damaged well bollard (minor repair to be made during site monitoring activities)

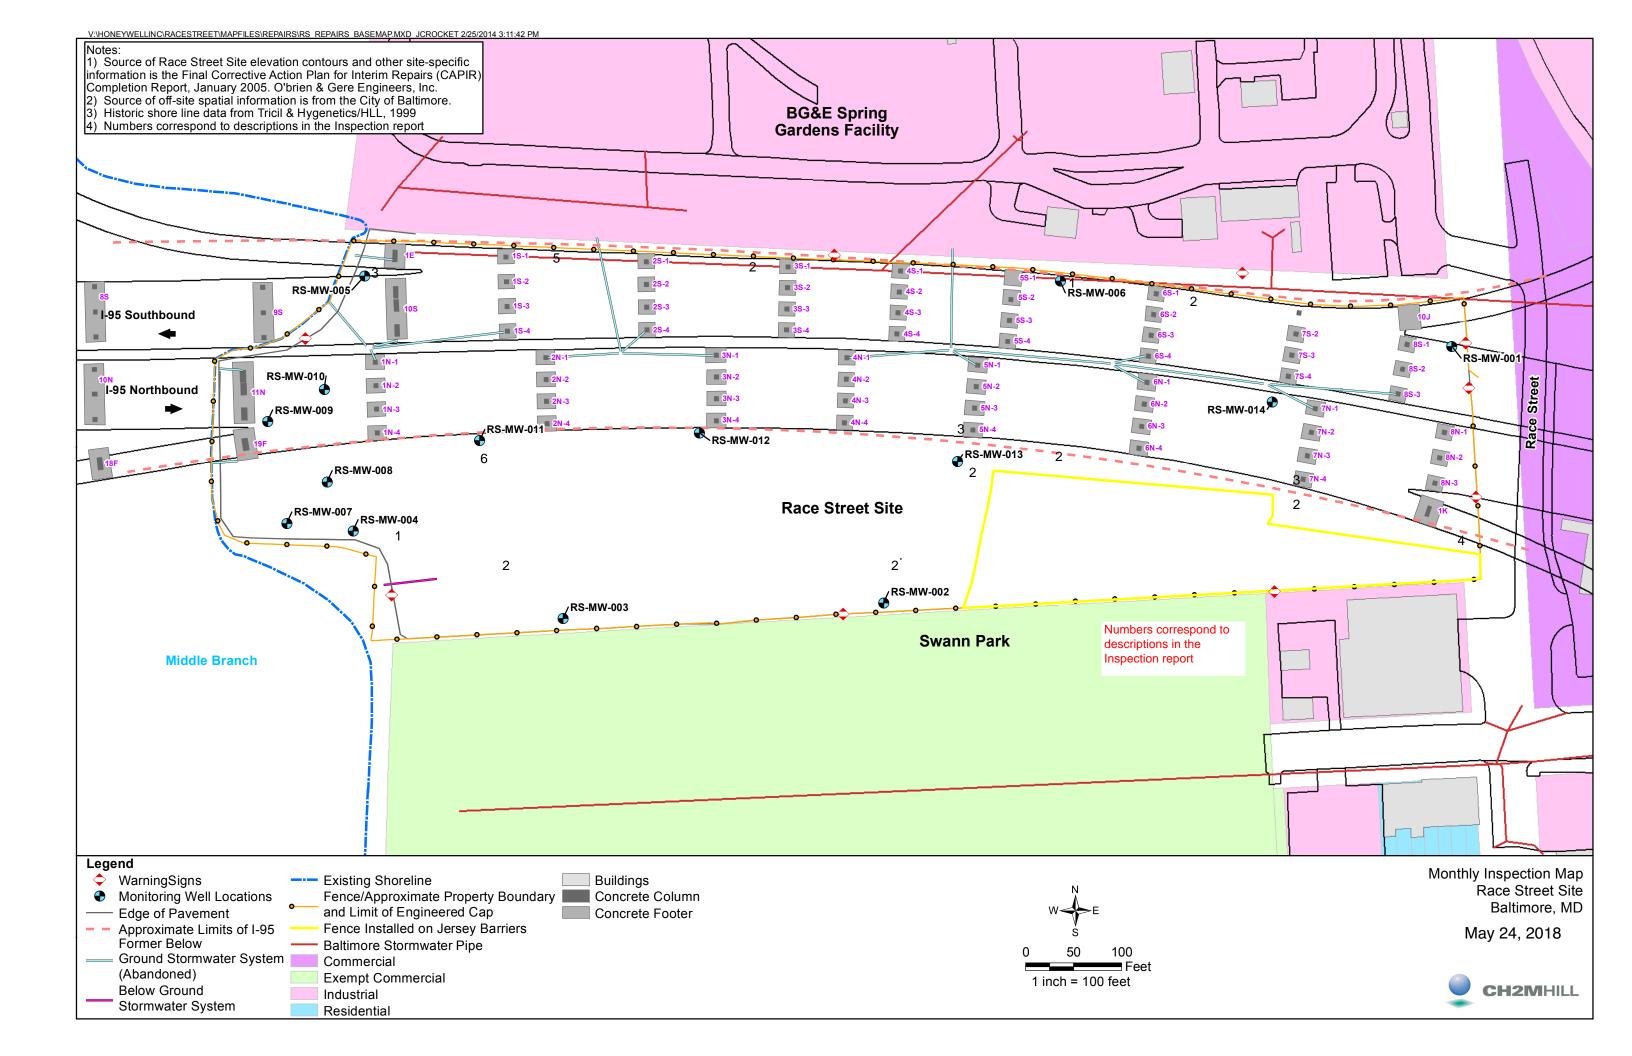
1. General	Observations	Actions Taken	Date Completed	Comments/Additional Observations
Inspect site for presence of surface debris. Identify	Sediment and debris accumulation. Trash accumulation	None	NA	Sediment, debris, and vegetation to be removed in Q2 2018 as part of scheduled site maintenance and cap repairs.
Inspect site for presence of vegetation. Identify estimated amount and location of vegetation via description or on Site Plan (attach to Monthly Site Inspection Checklist)	None	None	NA	NA

3. Engineered Cap				
Inspect cap for alligator cracking. Identify estimated area of cracking and location via description or on Site Plan (attach to Monthly Site Inspection Checklist)	None	None	NA	NA
Inspect cap for holes. Identify number of holes, width and depth, and location via description of on Site Plan (attach to Monthly Site Inspection Checklist)	None	None	NA	NA
Inspect cap for cracks less than 0.5 inches wide. Note number of cracks. Identify location of cracks via description or on Site Plan (attach to Monthly Site Inspection Checklist).	2: Locations with cracked asphalt with vegetation. 3: Location with a crack between pier footing and asphalt.	City of Baltimore notified	29-May-18	Surface cover repairs to be addressed during Q2 2018 as part of scheduled site maintenance and cap repairs. City notified of the need to implement vegetation management.
Inspect cap for cracks greater than 0.5 inches wide. Note number of cracks. Identify location of cracks via description or on Site Plan (attach to Monthly Site Inspection Checklist).	1: Crack in asphalt with vegetation.	City of Baltimore notified	29-May-18	Surface cover repairs to be addressed during Q2 2018 as part of scheduled site maintenance and cap repairs. City notified of the need to implement vegetation management.

7. Signage		1		
	None	None	NA	NA
8. Miscellaneous Items	1			1
Any interaction with people on or adjacent to the site? If yes, identify who, title, organization, contact information, and content of interaction	y interaction with people on or adjacent to the 2? If yes, identify who, title, organization, contact			
Other Comments/Observations?	6: Damaged well bollard (minor repair to be made during site monitoring activities)

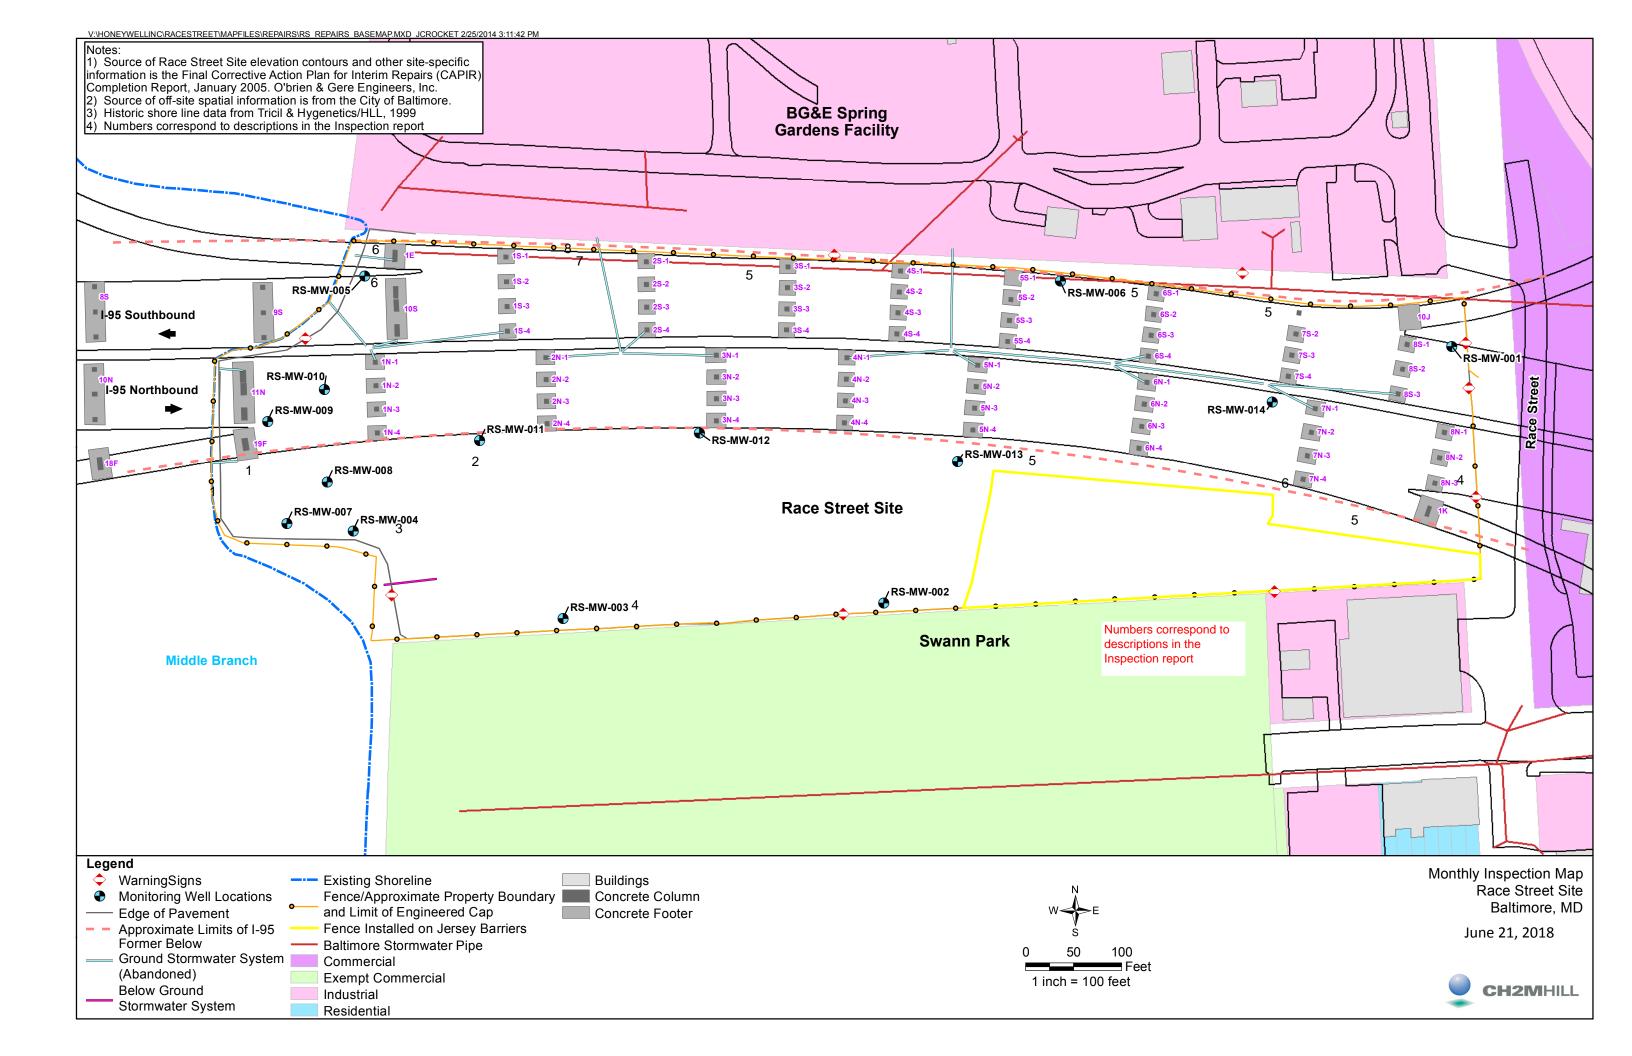
1. General	Observations	Actions Taken	Date Completed	Comments/Additional Observations
	8: Sediment and debris accumulation with vegetation growth	None	NA	Sediment, debris, and vegetation to be removed during Q2 2018 as part of scheduled site maintenance.
Inspect site for presence of vegetation. Identify estimated amount and location of vegetation via description or on Site Plan (attach to Monthly Site Inspection Checklist)	None	None	NA	NA

3. Engineered Cap				
Inspect cap for alligator cracking. Identify estimated area of cracking and location via description or on Site Plan (attach to Monthly Site Inspection Checklist)	None	None	NA	NA
Inspect cap for holes. Identify number of holes, width and depth, and location via description of on Site Plan (attach to Monthly Site Inspection Checklist)	7: Locations with vegetation	None	NA	Sediment, debris, and vegetation to be removed in Q2 2018 as part of scheduled site maintenance.
Inspect cap for cracks less than 0.5 inches wide. Note number of cracks. Identify location of cracks via description or on Site Plan (attach to Monthly Site Inspection Checklist).	5: Cracks in asphalt with vegetation 6: Crack between pier footing and asphalt.	None	NA	Surface cover repairs to be addressed in Q2 2018 as part of scheduled site maintenance and cap repairs.
Inspect cap for cracks greater than 0.5 inches wide. Note number of cracks. Identify location of cracks via description or on Site Plan (attach to Monthly Site Inspection Checklist).	3: Cracked asphalt	None	NA	Sediment, debris, and vegetation to be removed during Q2 2018 as part of scheduled site maintenance.

5. Aboveground Stormwater Conveyance System			.	
Inspect aboveground stormwater conveyance system including piping, downspouts, and drain in southwest corner of site for proper operation	1: Leak in downspout.	MDTA notified	7/11/2018	MDTA notified of need for inspection and maintenance of the down spout.

7. Signage		l		
	None	None	NA	NA
8. Miscellaneous Items	1	<u>'</u>	l	
Any interaction with people on or adjacent to the site? If yes, identify who, title, organization, contact information, and content of interaction	Al Simkins of MDE was on site for the monthly site visit.			
Other Comments/Observations?	2: Damaged well bollard (minor repair to be made during site monitoring activities)
