Subject: Transmittal of Quarterly Site Progress Report, Fourth Quarter 2014

2000 Race Street Site, Baltimore, Maryland

# Fourth Quarter 2014 Race Street Quarterly Site Progress Report, 2000 Race Street, Baltimore, Maryland

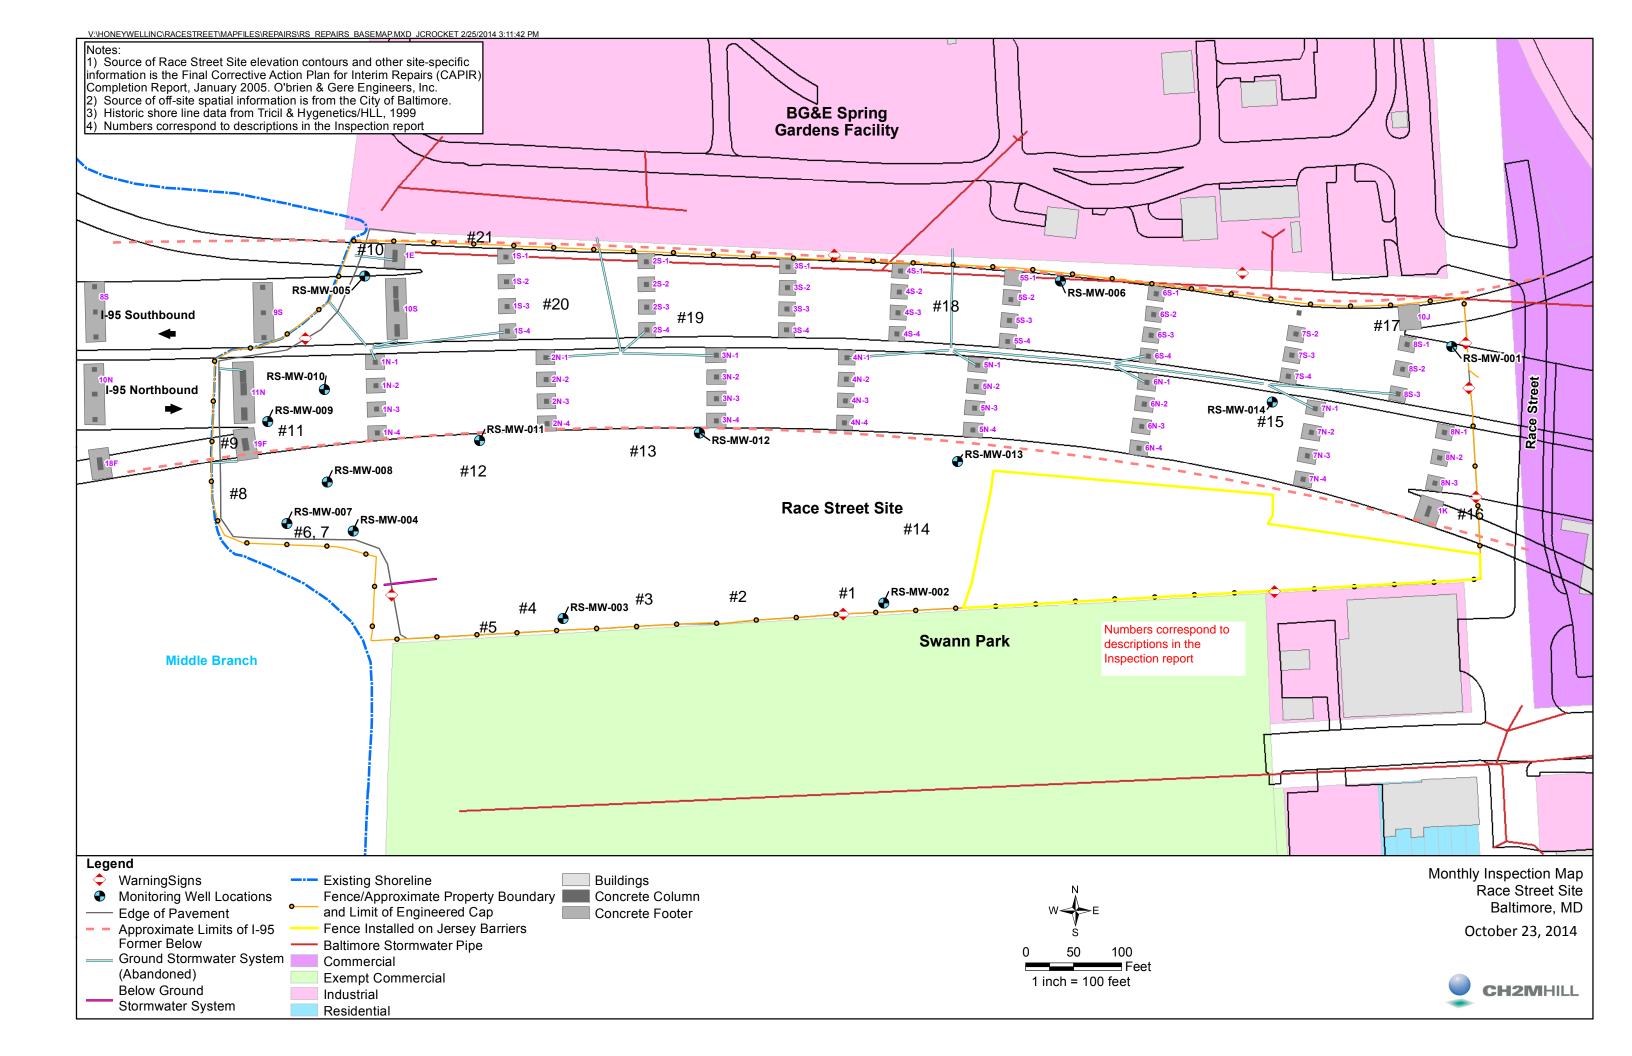
| Inspector: | Bill Morris | Date of Inspection: | 23-Oct-14 | |
|--|---|--|---|---|
| Inspect cap for alligator cracking. Identify estimated area of cracking and location via description or on Site Plan (attach to Monthly Site Inspection Checklist) | 1, 12, 13, 14: Alligator cracking in the asphalt surface. | Areas identified for site maintenance. | | Surface cover maintenance to be performed during Q4 2014. |
| Inspect cap for cracks less than 0.5 inches wide.<br>Note number of cracks. Identify location of cracks<br>via description or on Site Plan (attach to Monthly<br>Site Inspection Checklist). | 2, 3: Surface cracks in the asphalt; no vegetation present. | Areas identified for site maintenance. | First two weeks of October 2014 | Surface cover maintenance to be performed during Q4 2014. Vegetation has been removed from all crack features on the site in preparation for crack sealing. |
| Identify any other observations related to the condition of the cap and potential for cap damage | 5: Minor stress crack at the top of the slope. | Areas identified for site maintenance. | | Items to be addressed as part of the surface cover maintenance activities. |

| Site Inspection | Results | | | |
|---|---|---|---|---|
| Inspect aboveground storm water conveyance system including piping, downspouts, and drain in southwest corner of site for proper operation 6. Vandalism | 9, 17: Missing or disconnected storm water downspouts. | MDTA maintenance activities resumed. | 9/11/2014 | MDTA is performing bridge maintenance during Q4 2014. |
| Other Comments/Observations? | 7,15: Bent bollards. | | | |

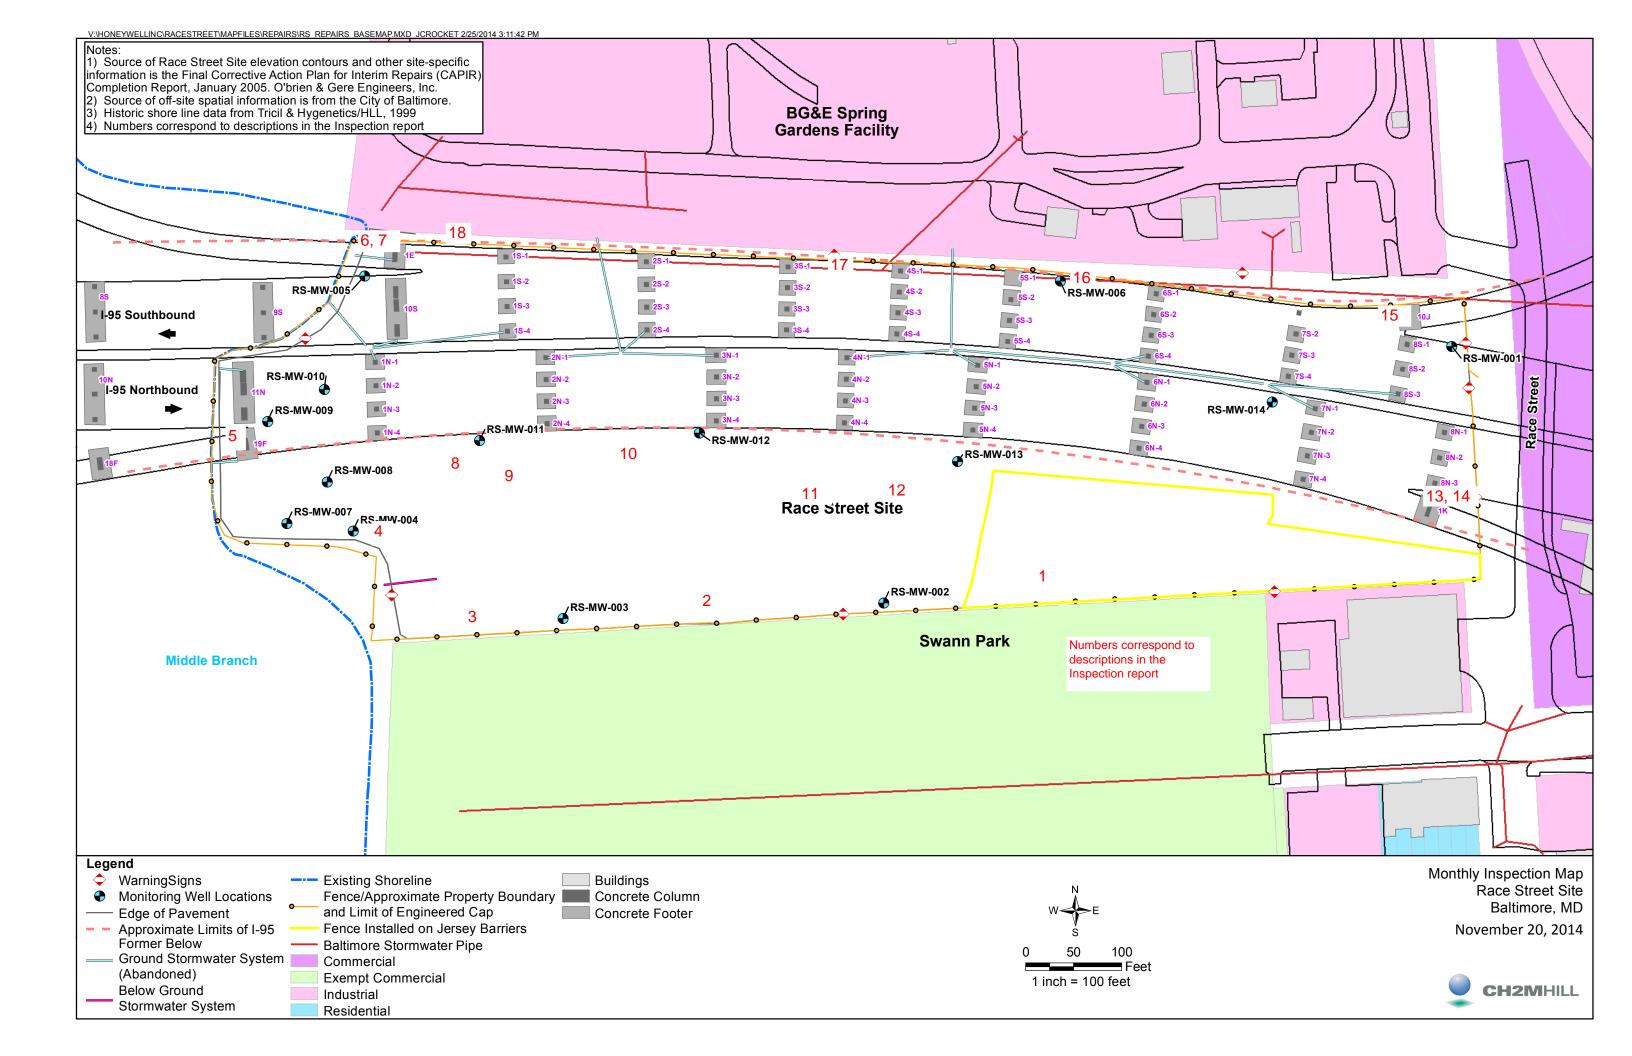
| Inspector: | Bill Morris | Date of Inspection: | 20-Nov-14 | |
|--|---|--|---|---|
| Inspect cap for alligator cracking. Identify estimated area of cracking and location via description or on Site Plan (attach to Monthly Site Inspection Checklist) | 8-12: Alligator cracking in the asphalt surface. | Areas identified for site maintenance. | | Surface cover maintenance to be performed during Q4 2014. |
